TECHNOLOGICAL DEGRADATION OF SHAFT SURFACE DURING MACHING

Summary: The paper deals with identifying the causes of surface failure of a shaft made of material 42CrMoS4. On the basis of microstructural analysis completed by hardness testing, the occurrence of undesirable phases, such as non-metallic inclusions in the structure of the shaft, can be demonstrated. In the presence of various heterogeneous phases in the material structure, plucking of particles can occur during chip machining which leads to surface damage. In the conclusion, the authors recommend checking the starting material, which can eliminate problems that cause the degradation of the surface of the shaft. The failure of the surface causes the notch effect which initiates further failures of the material.

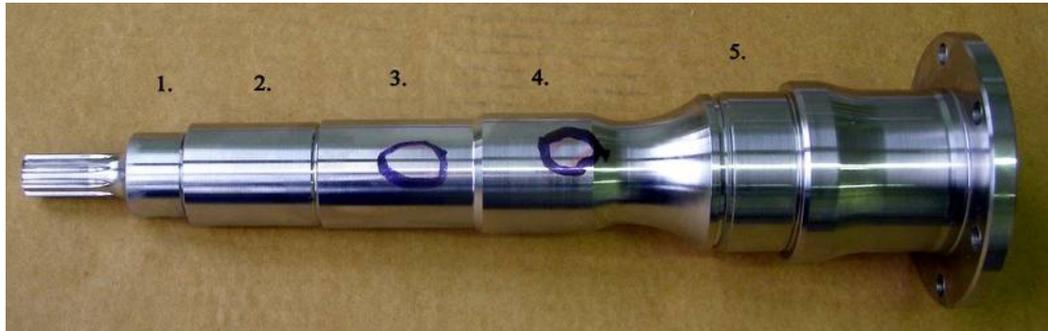
Based on the crack detection testing, shaft defects were indicated in the central part of the semi-finished shaft and they were further observed from the macroscopic and microscopic aspects. The shaft is made of material 42CrMoS4 and is shown in Fig. 2. The research was aimed at determining the surface damage causes and identifying the kind of damage in detail. The next task was to determine the extent of the damage to the shaft and to analyse how the damage can affect the basic material.

Fig. 2 - Damage to the shaft before further processing and hardness measurement points (1–5)

Measurement of the hardness of the basic material along the entire length of the shaft was carried out according to Brinell - HB_{5/750}, the measurement results are shown in Tab. 3, and individual measurement points are indicated in Fig. 2 (1-5). The average hardness with the measurement standard deviation is HB_{5/750} = 302.4 ± 11.3. The HMS 142 standard requires the specified hardness HB_{5/750} = 290 – 327 for shafts made of material 42CrMoS4.

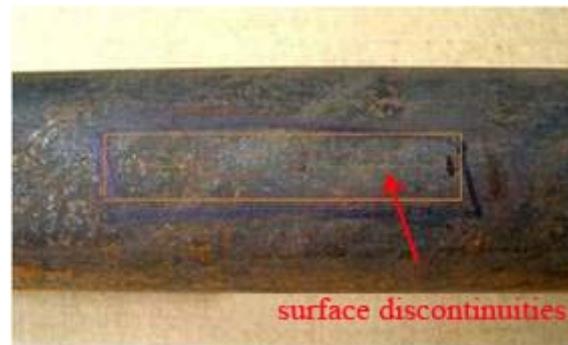
Based on the nature of the shaft defect identified by the crack detection, attention was paid to the starting material of the shaft. We used six semi-finished products from which cross sections were cut for the evaluation of microcleanliness after cutting from bar stock. On their surface macroscopical discontinuities were identified in one case, Fig. 3, which were marked for metallographic analysis sampling.

Fig. 3 - Starting material – surface discontinuities

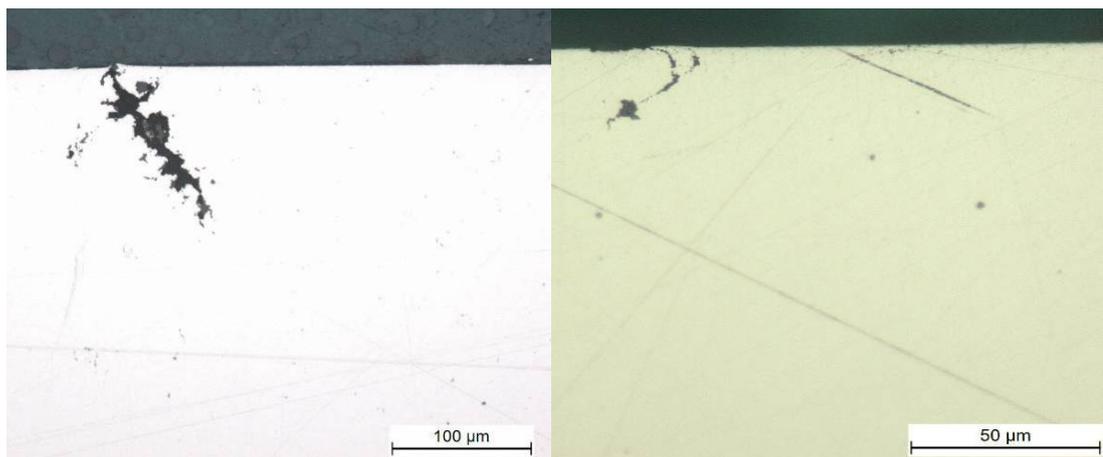
Microcleanliness rating revealed the presence of non-metallic inclusions in the central region and below the surface. From the macroscopically observed imperfections (scratches, cracks) of the shaft, see Fig. 3, cross sections were cut off to specify the kind of internal damage in detail. Occurrence of cracks was identified on the cross-section of a metallographic pattern; they were accompanied by oxidic phases, Fig. 4. The length of the crack was 0.135 mm and its depth 0.12 mm. Also a micro-overlap of depth 0.026 mm was identified below the surface.

200x magnified
Crack on the shaft surface

500x magnified
Micro-overlap around the
circumference of the shaft cross section

Fig. 4 - Microcracks and micro-overlaps below the surface of the damaged material of the shaft

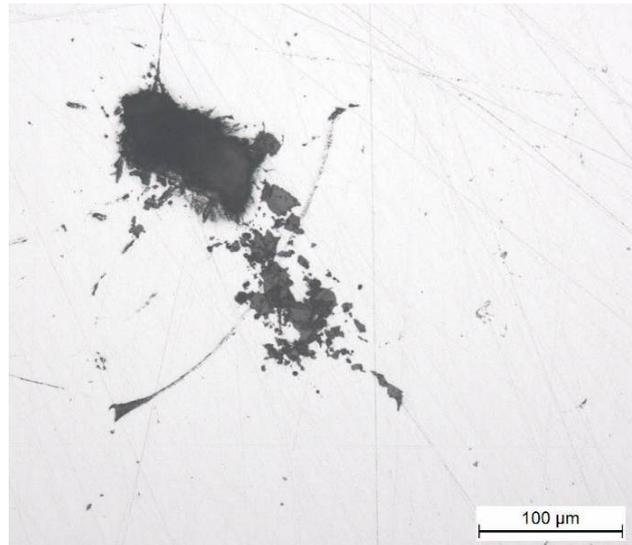
Fig. 5 - Cross-section of surface defects of the damaged shaft

When evaluating the cross section in the central region, lumps of contaminants with a cavity (Fig. 5) of size of 0.33 mm were identified. Based on these findings, a scratch pattern of the longitudinal section was prepared, where the detail of oxidic macro-inclusions, of the length of 12.5 mm, was recognized, Fig. 6, according to the HMS 142 standard (according to DIN 50 602). The detail of sulphides occurrence micro-cleanliness corresponds to level 3, Fig. 7, according to the STN EN 10 247 standard. The microstructure of the damaged shaft in the crack region, Fig. 4, is formed by high hardened martensite, or fine sorbitol and ϵ - carbide, which is documented in the etched and non-etched state of the cross-section in Fig. 8. In the crack region no decarburization of the basic material was observed.

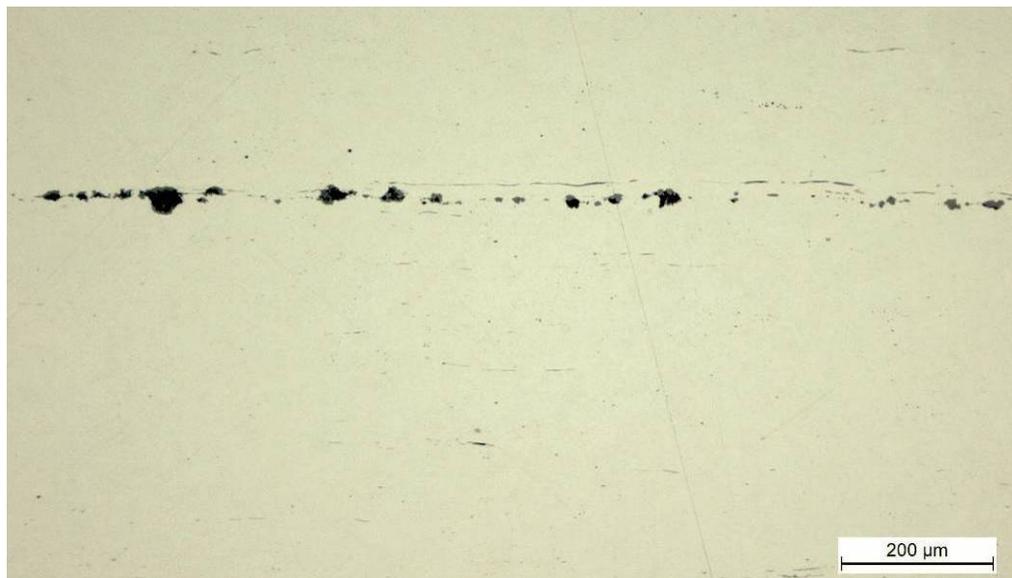
Fig. 6 - Macro-inclusions in the body of the damaged shaft - longitudinal section

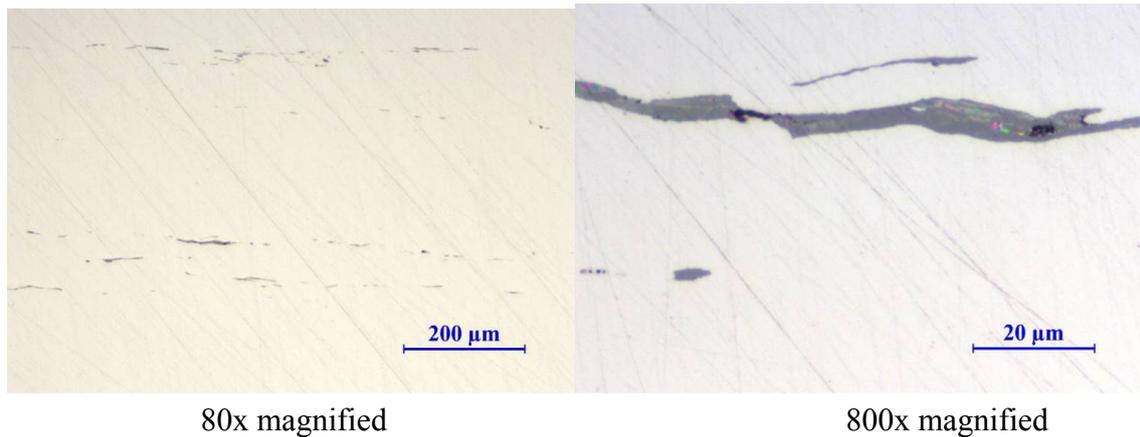
Fig. 7 - Sulphidic phases in longitudinal section

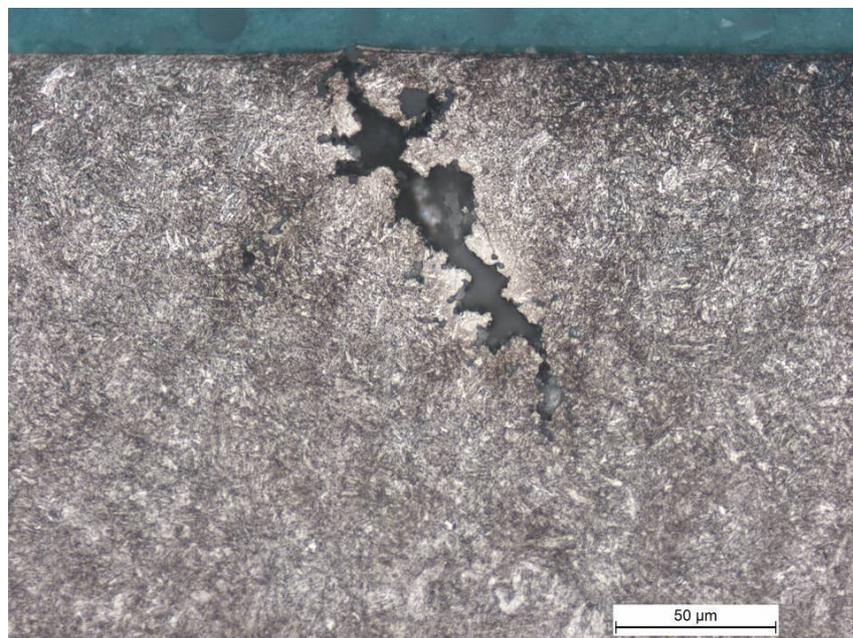
Fig. 8 - Microstructure of the crack region of the damaged shaft

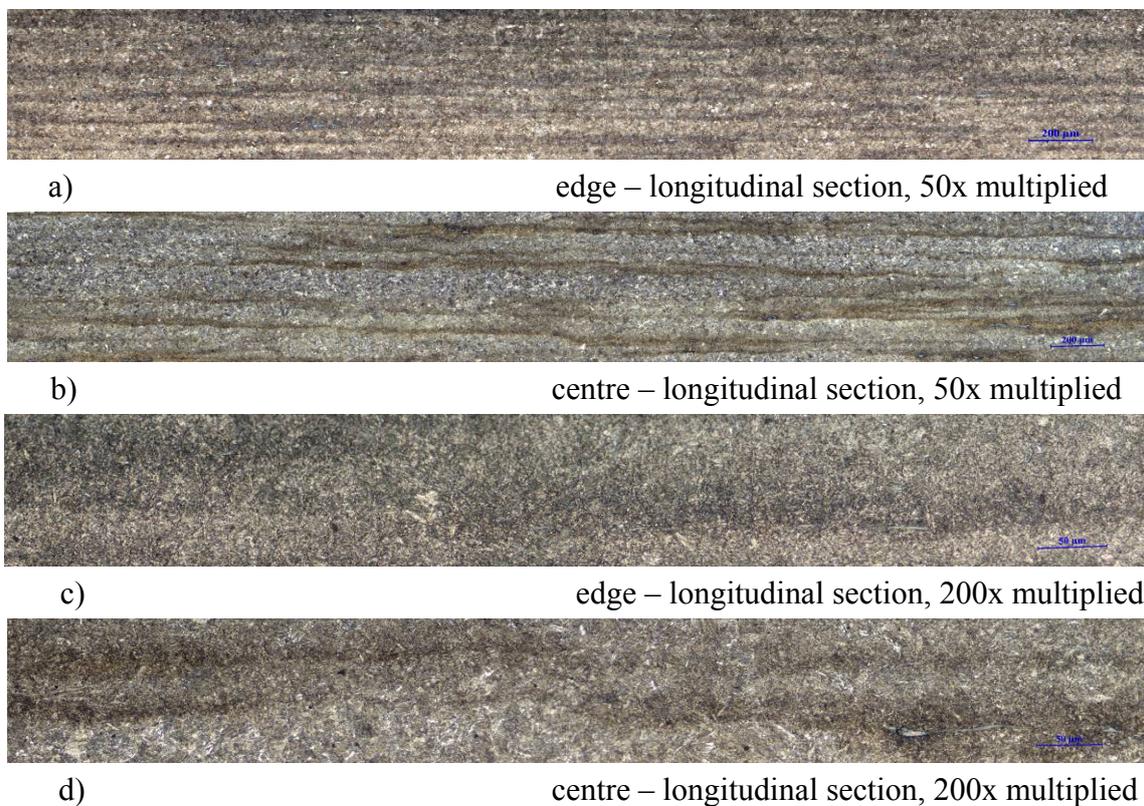
Changes in the microstructure of the basic material were only in the directing of the initial microstructure, which remained after the material forming technology. The Fig. 9 shows longitudinal sections of the microstructure on the edge and in the central region of the metallographic sample, see Fig. 9a, b, c, d for different magnifications. These structures indicate that the semi-finished product shows finer arrangement of microstructure particles in unconnected lines in the peripheral region below the surface. More significant coherent arrangement with wider lines was observed in the central region. With higher 200x magnification, it can be seen that the arrangement of carbide particles is not so significant. It is a larger scatter and thus the directing is not so sharply defined. Such microstructure is still acceptable in terms of further processing of the semi-finished product to the finished product. Microstructure detail - see Fig 10.

Fig. 9 - Microstructure of sample No. 2 longitudinal section

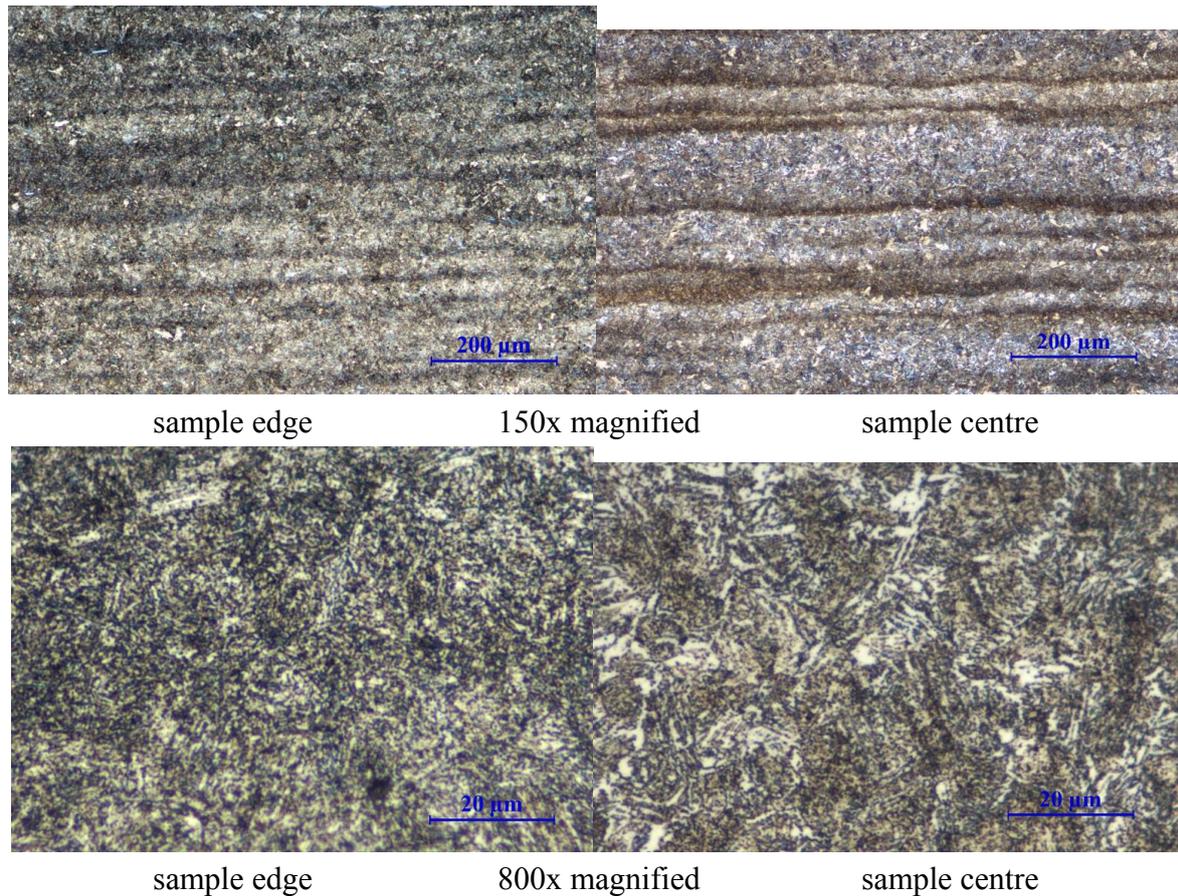
Fig. 10 - Detail of longitudinal section microstructure of sample No. 2
