PROBLEMS OF PARKING ON SELECTED STREETS IN PRAGUE

Summary: The paper deals with problems of parallel parking in selected localities of the capitol Prague. There are described the conflict situations on three streets with parking lanes and also with cycling lanes or a tramway lane. The article also presents evaluation of frequency of conflict situations in the monitored localities defining the conflict indicators (almost-accident rate). It further points at hidden factors that cannot be deduced from the project or analysis of the traffic accident rate.

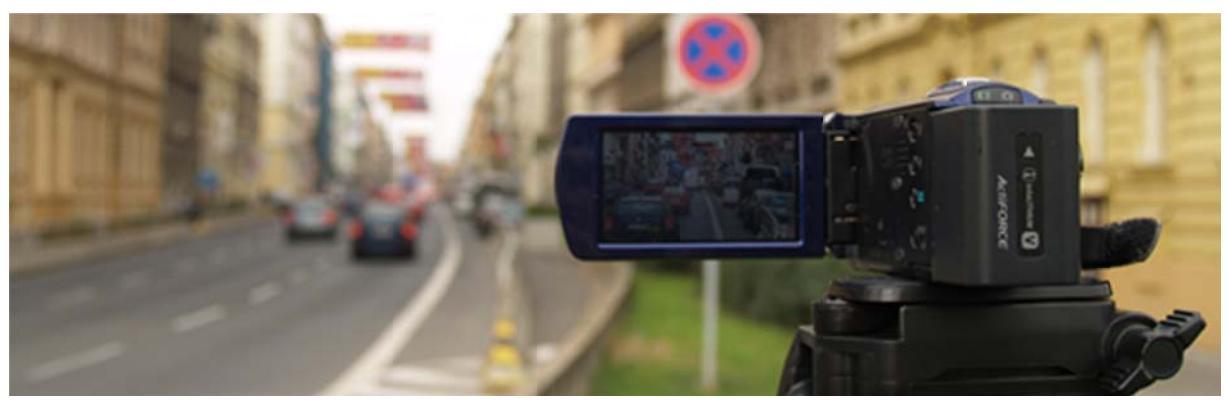
Fig. 1 - One of points for video analysis of conflict situations of parallel parking

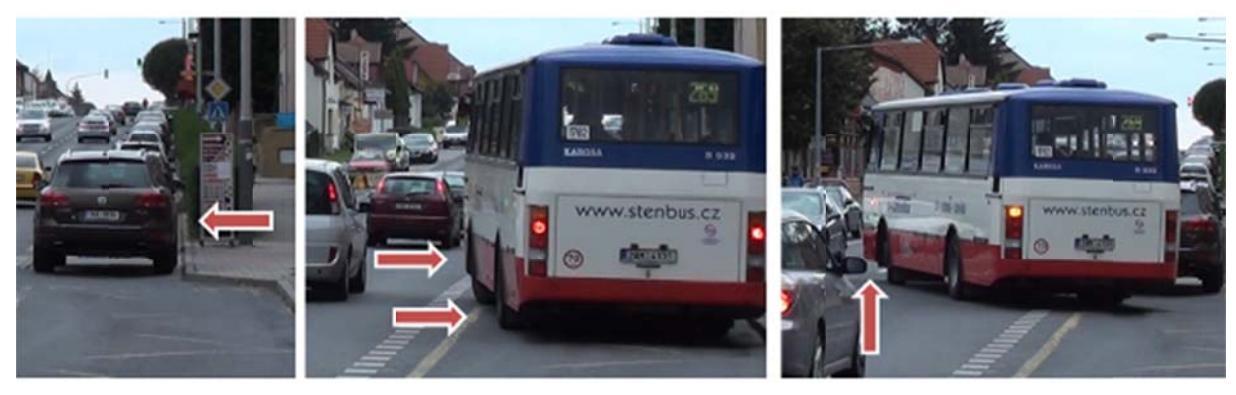
Vehicles often stop in front of or behind the stop lane. It noticeably influences driving of buses into the stop lane, its position near usable platform edge when passenger has to entry on road during getting on/off bus. And consequently bus exiting into the through lane is also influenced. Bus often drives into the opposite lane and it restricts vehicles going in opposite direction. This situation is shown in Fig. 3. This phenomenon is worse in articulated bus when the cutting of this vehicle was almost 1.15 m.

Fig. 3 - Parked vehicle influencing position and exit of bus from stop lane (2b2)

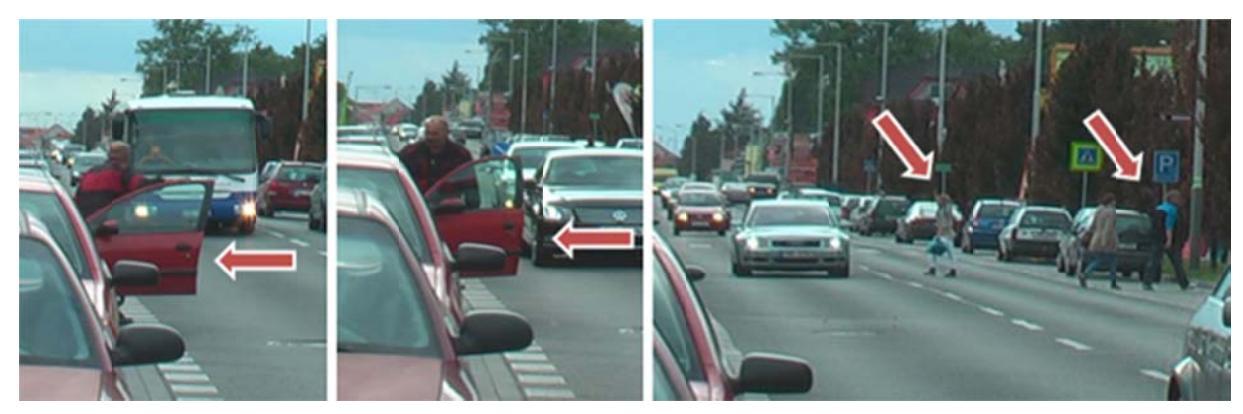
The other situations are caused by pedestrians. They are especially drivers of parked vehicles. Driver after parking manoeuvre must open the door during getting out and then entry into traffic lane. Open door sticks out into next traffic lane. Then the driver goes around vehicle walking on the traffic lane. This situation arises also during exiting the parallel

parking place. Vehicles in the next traffic lane are restricted and the driver of the parked vehicle is also endangered (Fig. 4).

Source: Authors Fig. 4 - Open door during getting in/out vehicle; crossing drivers (pedestrians) (4j2 and 4ch2)

Common phenomenon is also crossing across the road to or from the parked vehicle. Drivers rarely use the nearby pedestrian crossing. In these cases the vehicles are restricted again and the driver (pedestrian) himself is also endangered – see Fig. 4 and 5.

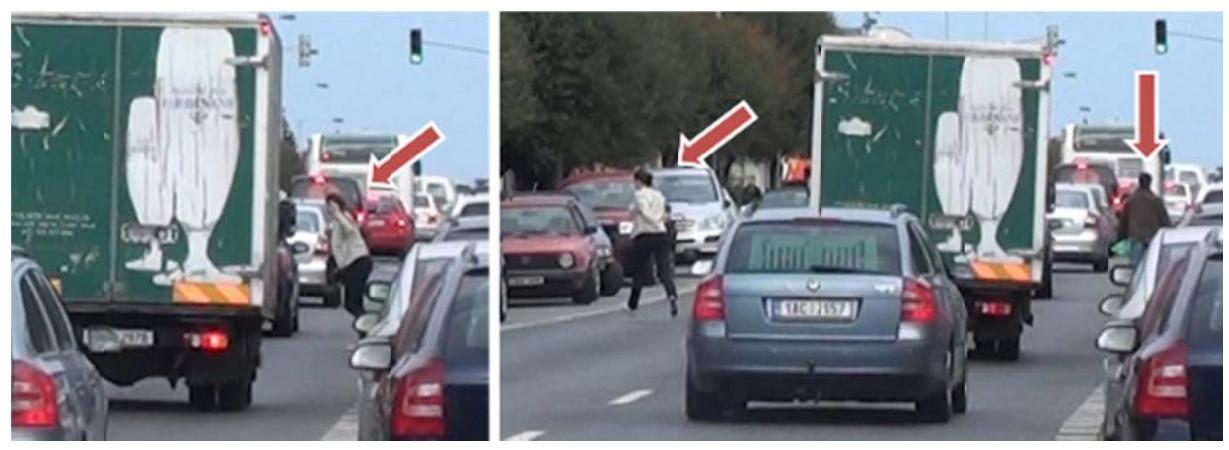
Fig. 5 - Driver of van is braking before crossing driver (4ch3)

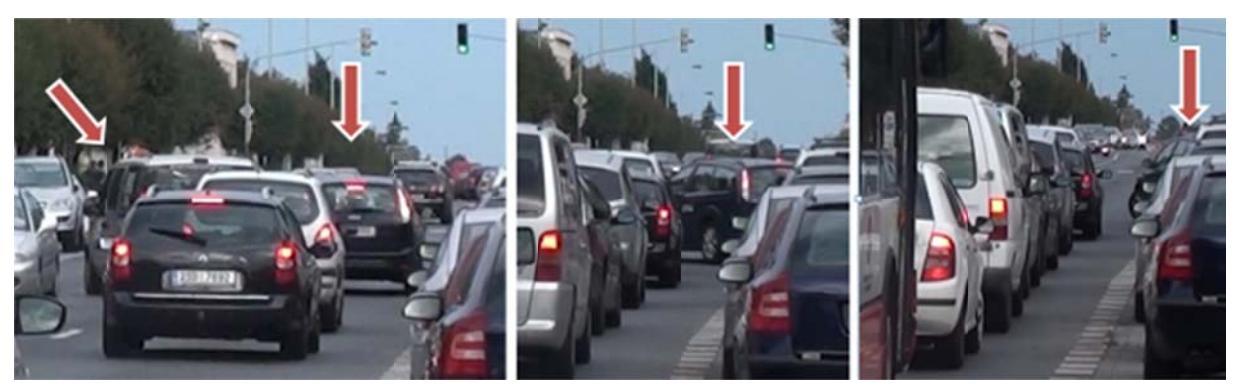
Drivers which are parking into parallel parking can restrict or decelerate vehicles behind them. This situation arises in the through lane while the driver looks for space for parking of his vehicle. However, the considerable restriction of vehicles in the through lane arises during parking manoeuvre into parallel parking place by reversing. In these cases the driver stops in the through lane and reverse into parking place. There could also be situations in which the driver suddenly stops near space for parking of a vehicle. Another situation arises when drivers try to pass this vehicle or stop close behind it. Driver of the parking vehicle cannot enter into this place by reversing. The observed

manoeuvre is shown in Fig. 6 and it takes 35 seconds from stopping of the vehicle in the traffic lane to further movement of vehicles in the through lane.

Fig. 6 - Parking by reversing (6z2)

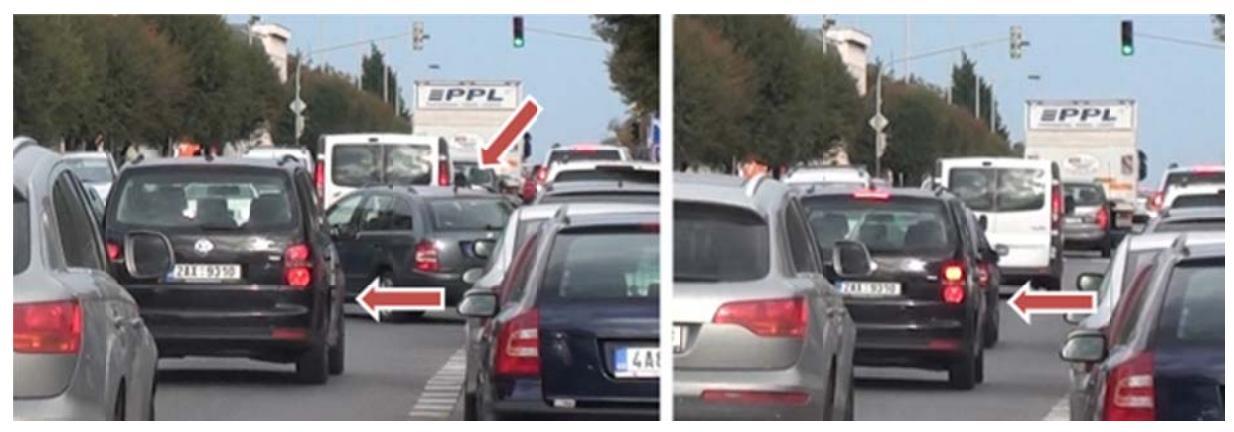
Problematic and also potentially dangerous situations arise during unexpected exit of parked vehicles from the parallel parking place. If a car stands hidden behind other vehicles in parallel parking place and it gives a turn indicator, this signal may not be visible for other drivers. The driver drives into the through lane in the space between vehicles, but this manoeuvre is unexpected by the drivers going behind him. This manoeuvre is shown in Fig. 7. In this case the driver of the exiting vehicle did not use the turning indicator. Vehicle in the through lane had to brake suddenly in order to avoid traffic accident.

Fig. 7 - Unexpected exits from parallel parking place and danger for vehicles in through lane (6v3)

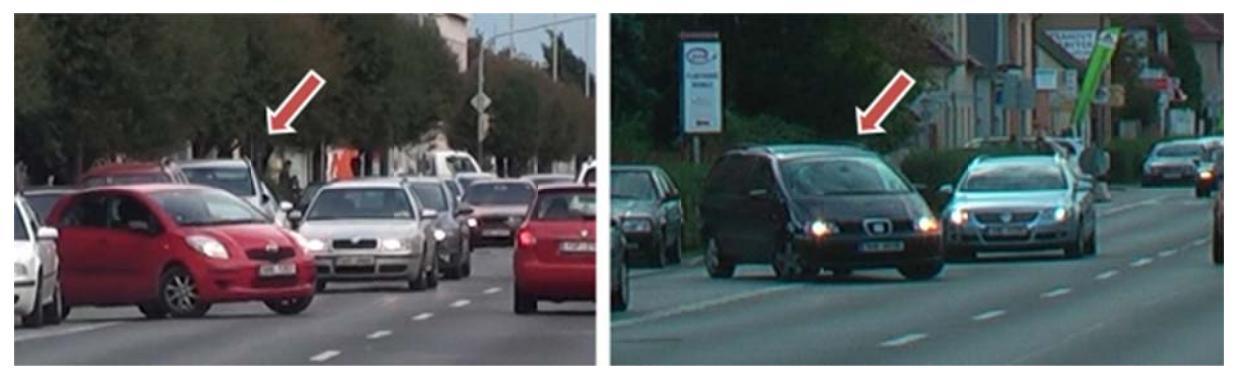
Another dangerous situation is the U-turn manoeuvre of vehicles on road during exit of the parallel parking place. In these cases the drivers in traffic lanes (especially drivers in the opposite traffic lane) do not expect a U-turn manoeuvre through the road – see Fig. 8.

Fig. 8 - U-turn manoeuvre of vehicles during exit of parallel parking place (603)

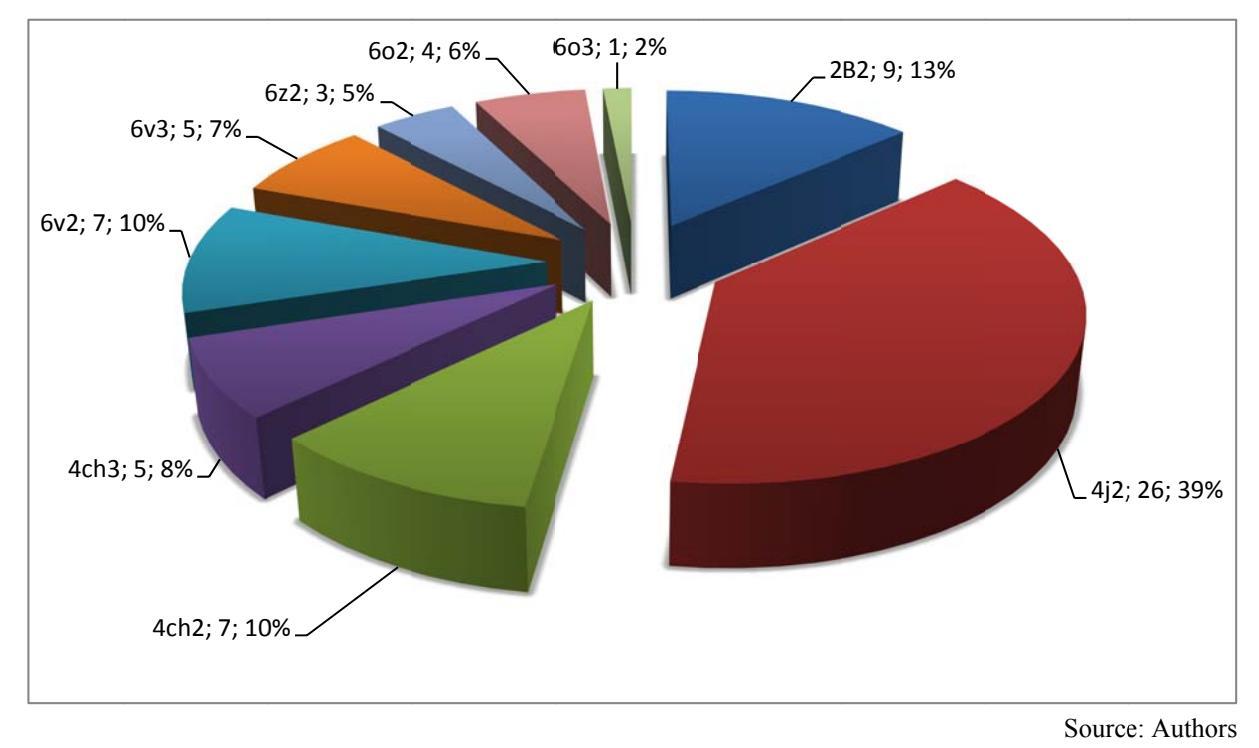
Fig. 9 shows percentage of conflict situations recorded in the monitored locality. At Náchodská street there mostly appear 4j2 – opening doors into the road (total of 1.59 KS/100 veh.), 2b2 – a public transport vehicle pulling out into the opposite lane due to a parked passenger vehicle (0.55 KS/100 veh.), 4ch2 – pedestrians crossing the road (0.43 KS/100 veh.) and 6v2 – turning from the parallel parking to the through lane (0.43 KS/100 veh.).

Fig. 9 Total of conflict situations in Náchodská street

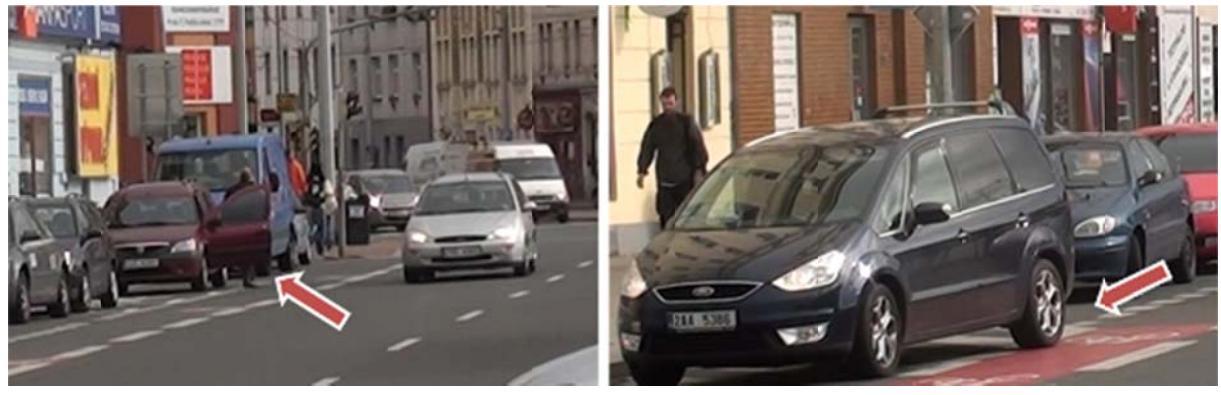
As already mentioned in the previous locality, driver must open the door and enter into the road after parking manoeuvre during getting out. In this case the open door sticks out into the neighbouring cycling lane. Driver of the parked vehicle is separated from the through lane and the door does not stick out into this lane. However, in this place, there arise dangerous situations for cyclists who do not have manoeuvre place for averting this situation or they must go into the through lane or stop. This problem also arises in the case of vehicle which does not park adequately near the curb and sticks out into the cycling lane by rear part of the vehicle. Vehicle from Fig. 11 is parking outside the marked parallel parking place.

Fig. 11 - Open door into the cycling lane and vehicle sticking out into this lane by its rear part (4j2)

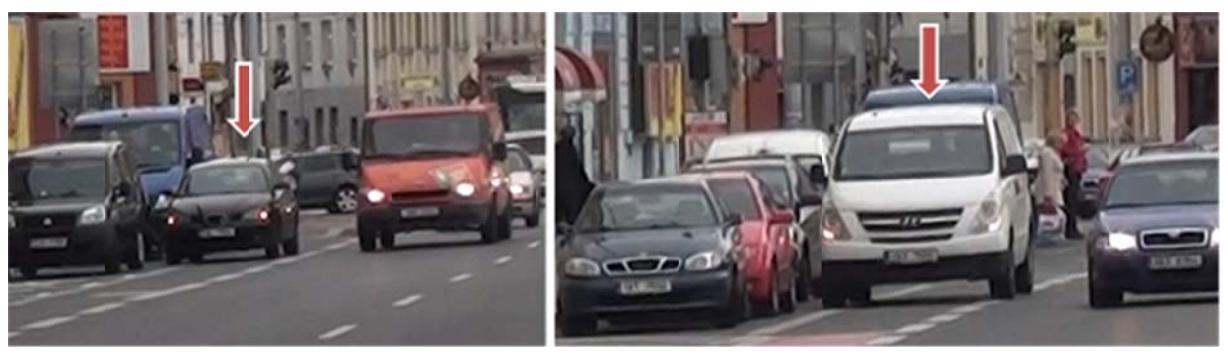
During the measuring we have also discovered that stopping of a vehicle in the cycling lane is a common phenomenon. There is a conflict situation not only during driving around the vehicle by a cyclist, but also by movement of drivers (pedestrians) in the next traffic lane. This problem was described in the previous monitored locality. We have to mention that drivers of these vehicles usually stop in the cycling lane even in the case,

when there are places available in the parallel parking places. Vehicles from Fig. 12 were standing in these places for more than 20 minutes.

Fig. 12 - Parked vehicles in cycling lane (2c2)

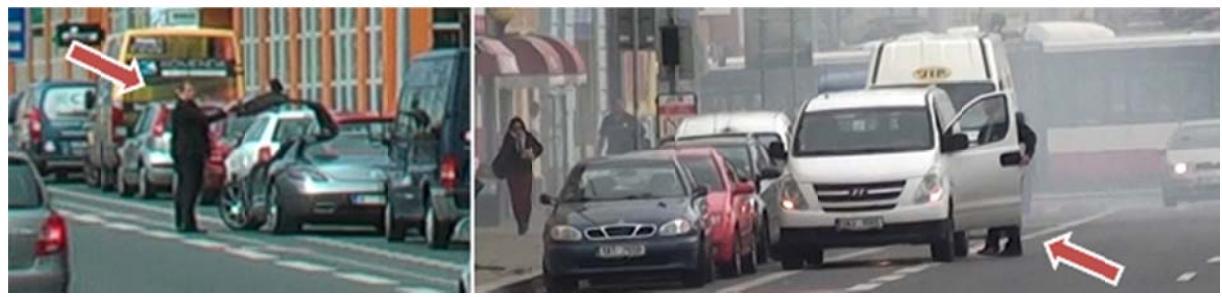
Open door of this parked vehicle sticks out into the next traffic lane. In this case there arise situations which were described above. Drivers moving on the road are shown in Fig. 13.

Fig. 13 - Moving of drivers on the road close to vehicles sticking out into cyclist lane (4j2)

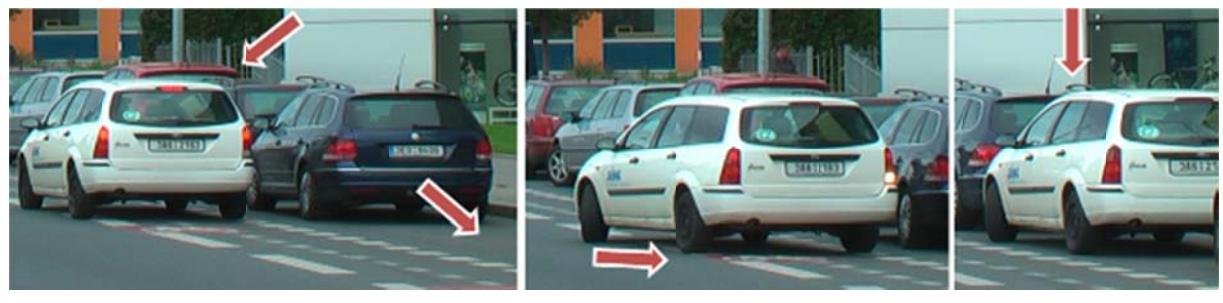
Drivers parking into the parallel parking use cyclist lane to stop their vehicles and to manoeuvre by reversing – see Fig. 14. In these cases the traffic in the through lane isn't influenced so much. Also the cyclists are influenced during this manoeuvre.

Fig. 14 - Vehicle stopping in cycling lane and reversing into parallel parking lane

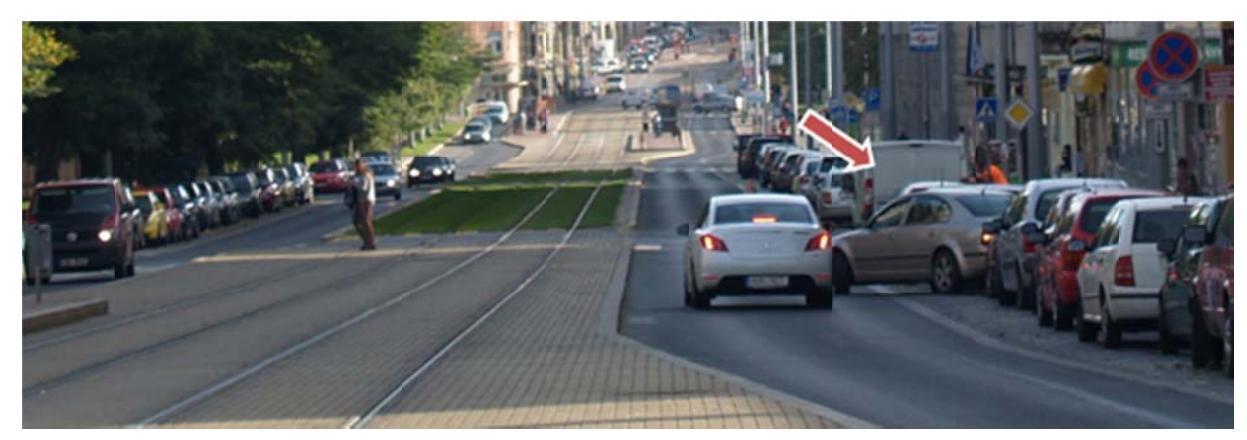
Due to only one traffic lane there is delaying of vehicles during parking manoeuvres into the parallel parking place. The dividing tram strip is elevated and during these situations it makes passing of vehicles impossible.

Fig. 17 - Parking manoeuvre into parking lane by reversing (6z2)

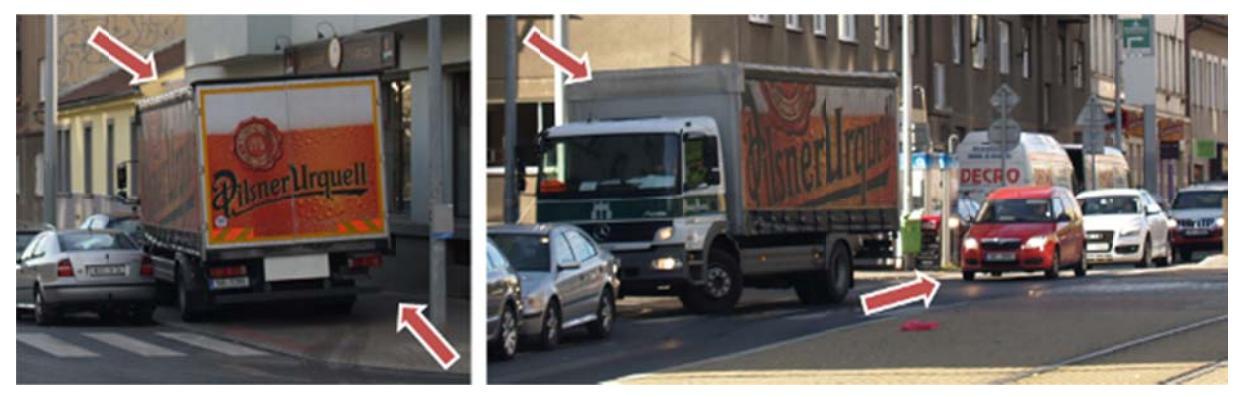
Close to restaurants, shops and other buildings of civil facilities there are often cases when the delivery vehicle cannot stop on the parallel parking and supply these buildings from its rear part. Such vehicles usually park on the pavement. Thus parked vehicle makes walking of pedestrians and disabled persons impossible. Traffic safety is also endangered during exiting of this vehicle. Fig. 18 shows a delivery vehicle exiting by reversing into intersection. This vehicle restricts drivers on major road, but also on minor road as the drivers do not expect this manoeuvre.

Fig. 18 - Supplying vehicle exiting by reversing into intersection (6r2)

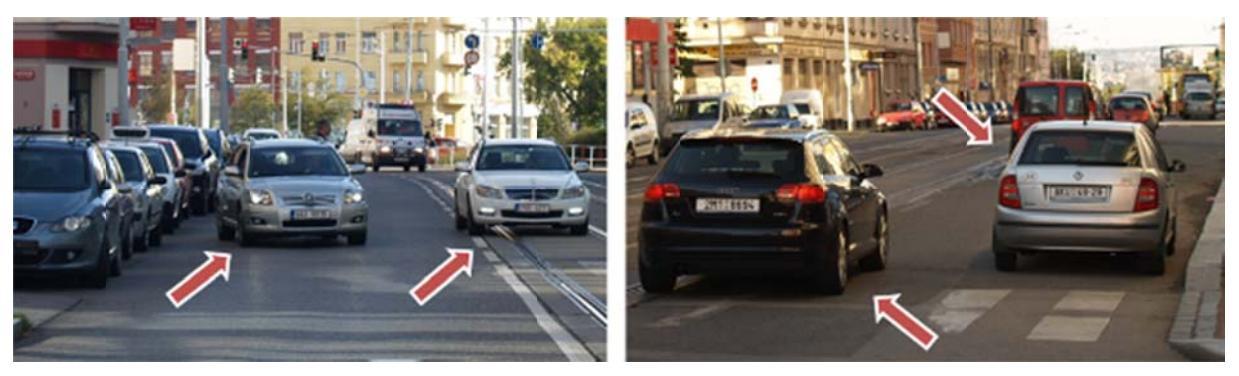
During observation on monitored localities we recorded a common phenomenon when drivers park along the road or the parallel parking place for the short period of time. Drivers in the through lane must pass this vehicle via the tram lane – see Fig. 19. There are dangerous situations when a driver passing the vehicle does not notice the approaching tram (especially in the case of bigger traffic volume in the traffic lane).

Fig. 19 - Passing parked vehicles via tram lane (6k2)

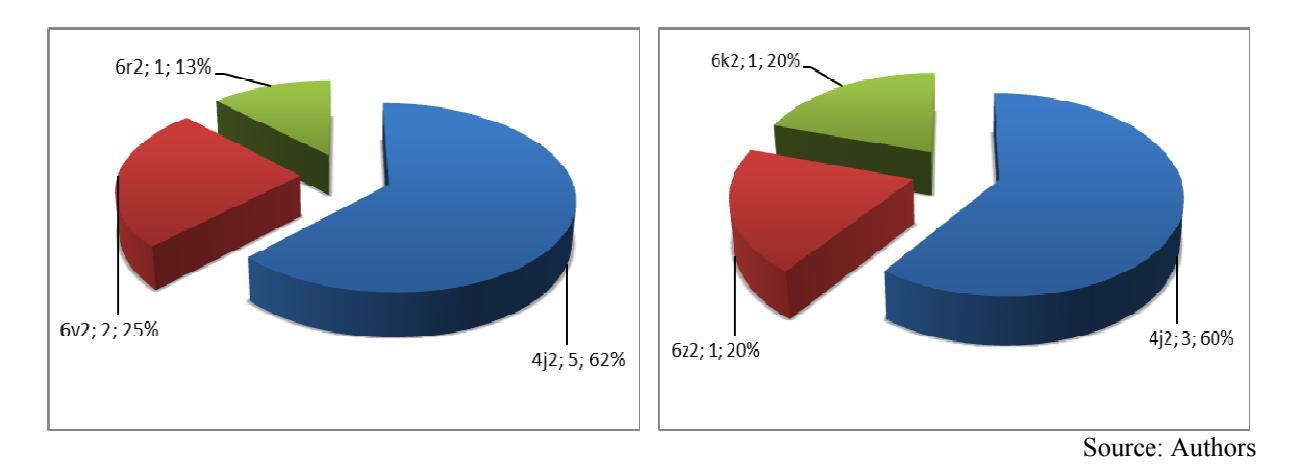
Fig. 20 shows percentage of conflict situations recorded in the monitored locality at Sokolská and Sokolovská street. At Sokolovská street, there was recorded a potentially dangerous situation $6r_2$ - reversing manoeuvre of a delivery vehicle into the intersection. The primary problematic situation at Sokolská street was $6k_2$ – passing of a badly parked vehicles via tram lane, where the mentioned 1070 vehicles passed a vehicle parked close to the pedestrian crossing via the tram lane.

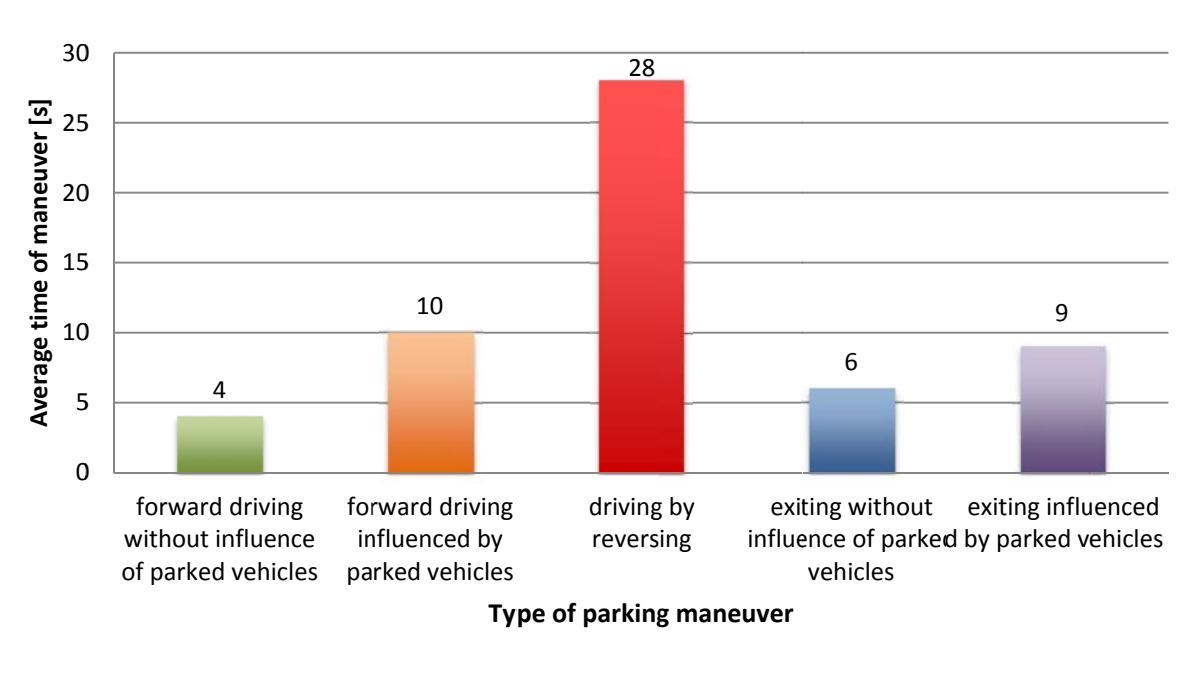
During the road traffic survey and video analysis of conflict situations there were recorded times of delay during the parking manoeuvres. Fig. 18 shows the average times of parking of vehicles according to the type of manoeuvre into the parallel parking. The graph demonstrates that the most appropriate manoeuvre is the forward driving without influence of the parked vehicles, when the driver of the parking vehicle can use one or more free parallel parking places. The most inappropriate manoeuvre is situation when the driver of the parking vehicle must use reversing for parking manoeuvre into the parallel parking place. In such case there is marked delay of flow of vehicles in the through lane.

Fig. 21 - Type of parking manoeuvre and its average times
